Windstorm Mitigation Report

Eastwood Shores Condominium No. 6

Clearwater, FL

As of 02-19-2019 | FPAT File# MUD2523480

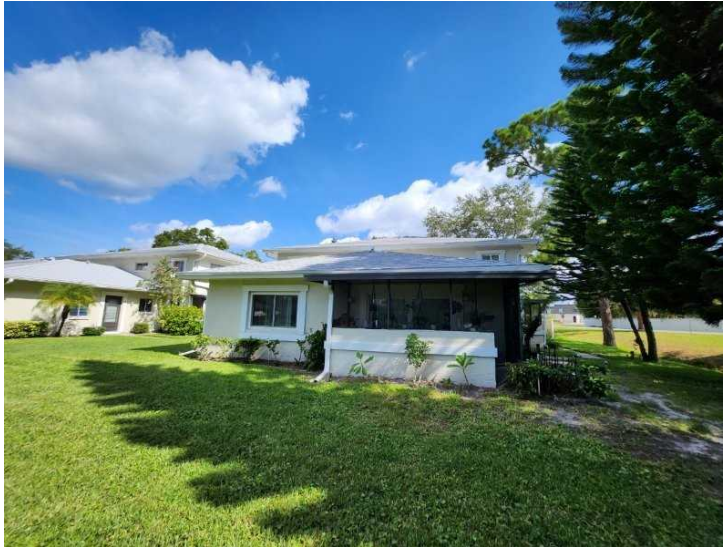
Roof Permit Information

Record EBP-23-09507:
Express Building Permit
Record Status: Finalized
Expiration Date: 12/10/2023

Permit Information	
Residential or Commercial Construction:	Commercial
Permit Type:	Roofing
Sub Type:	Shingle and/or Flat
Permit Expiry:	12/16/2023
Value of Construction:	140000

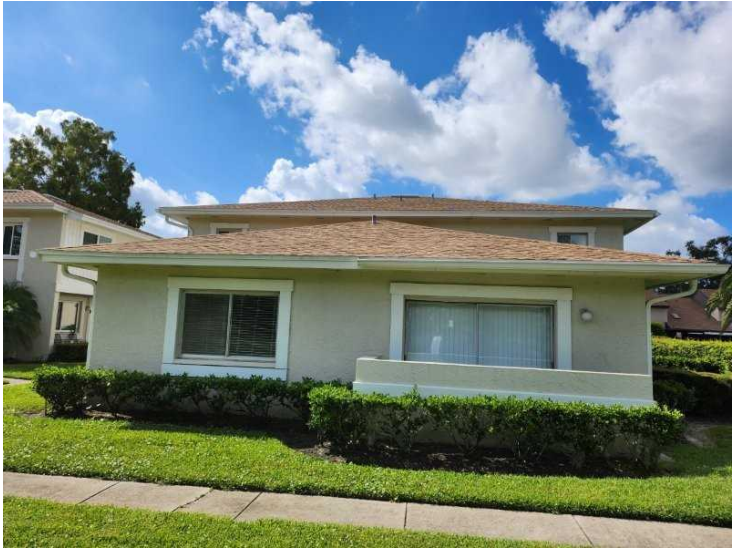
Roof Permit
Information

Record EBP-24-21526:
Express Building Permit
Record Status: Finalized
Expiration Date: 06/14/2025

Permit Information	Residential
Residential or Commercial Construction:	Roofing
Permit Type:	Shingles and/or Flat
Sub Type:	06/14/2025
Permit Expires:	21200
Value of Construction:

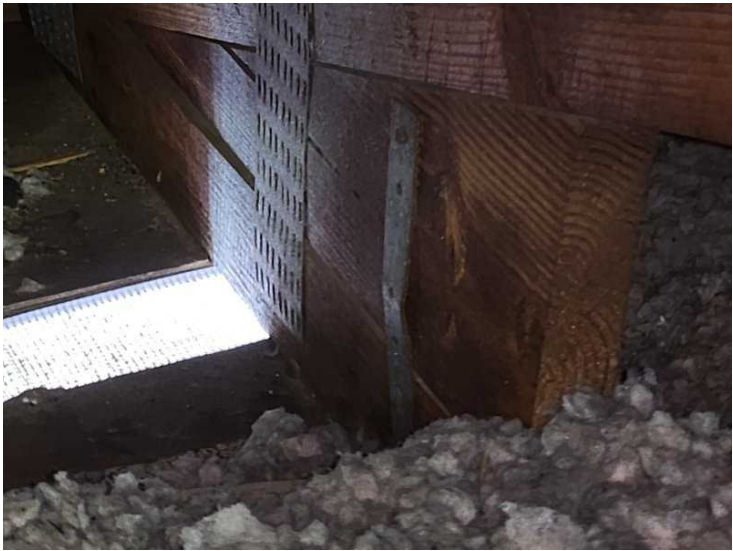
Roof Permit
Information

Record EBP-24-21882:
Express Building Permit
Record Status: Finalized
Expiration Date: 10/01/2025

Permit Information	Residential
Residential or Commercial Connection:	Roofing
Permit Type:	Shingle and/or Flat
Sub-Type:	10/01/2025
Permit Expires:	21200
Value of Construction:

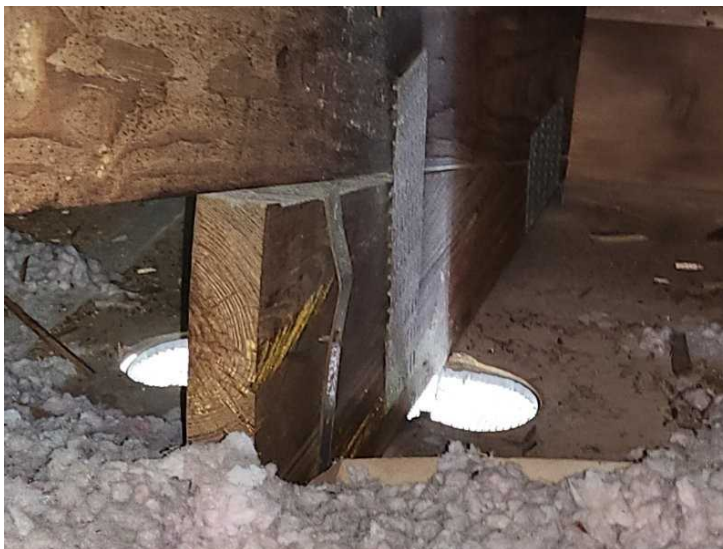
Roof Permit
Information

Record EBP-24-21903:
Express Building Permit
Record Status: Finalized
Expiration Date: 06/14/2025

Residential
Roofing
Shingle and/or Flat
06/14/2025
27200
